2.0 Summary of Construction Activities

3.0 Summary of Engineering Revisions

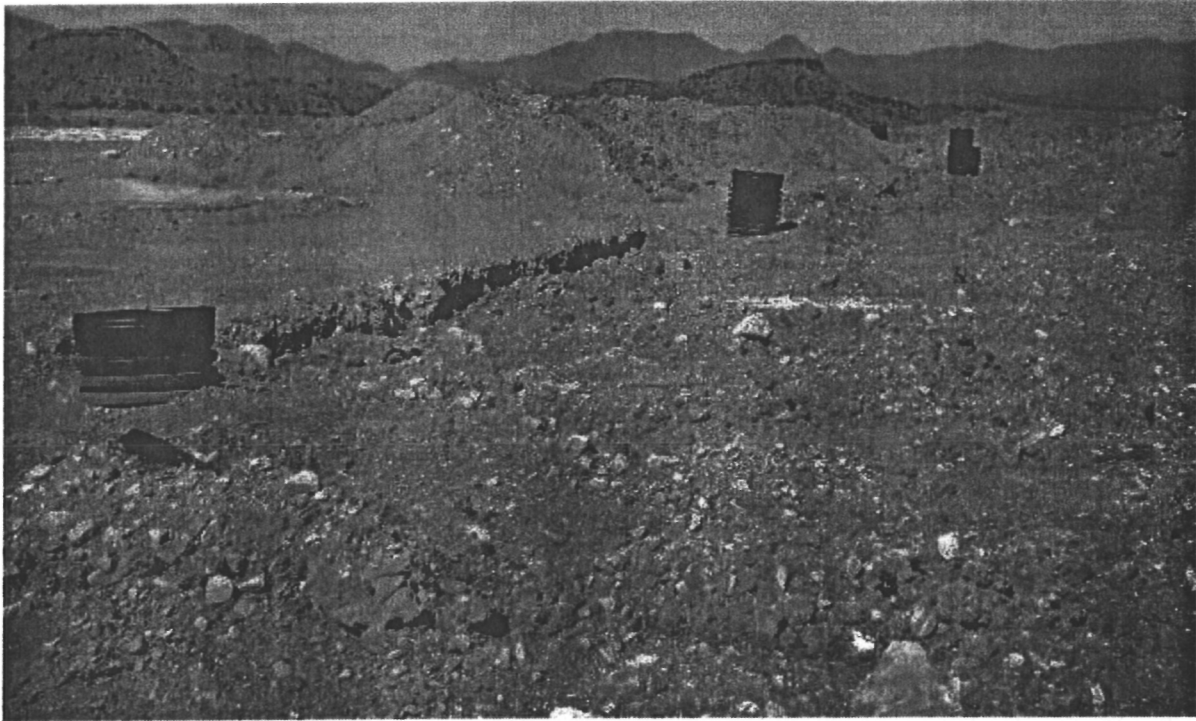
The system included excavation of eight foot deep trenches, approximately 50 feet in from the embankment edge. Large diameter (24") vertical sumps were then placed into the trench every 50 feet and were interconnected by small diameter (4") slotted filter pipe. The small pipe was placed to allow drainage to the vertical sumps. The initial temporary evaporation ponds were shallow (less than 1 foot in depth), lined with 6 to 10 mil black plastic, divided into relatively small cells (20 feet by 20 feet), and constructed on top of the impoundment. Sumps were pumped as frequently as possible into the temporary evaporation pond. The system produced low quantities of liquids, typically between one to two feet of liquid in the bottom of each sump. This fluid needed to be pumped out before more would flow into the sump. Through careful daily management of the sump and pumping system, evaporative potential was maximized. The photograph on the following page shows a series of interconnected vertical sumps on the northeast side of the impoundment after installation.

The alternative system consisted of installing a system of interconnected vertical sumps and temporary evaporation ponds to quickly lower the phreatic surface and permanently evaporate fluids during the summer months. The system was initially installed where the phreatic surface was slightly higher than the existing impoundment liner. These were locations where temporary collection evaporation ponds had been constructed outside of the impoundment and at other historic seepage locations.

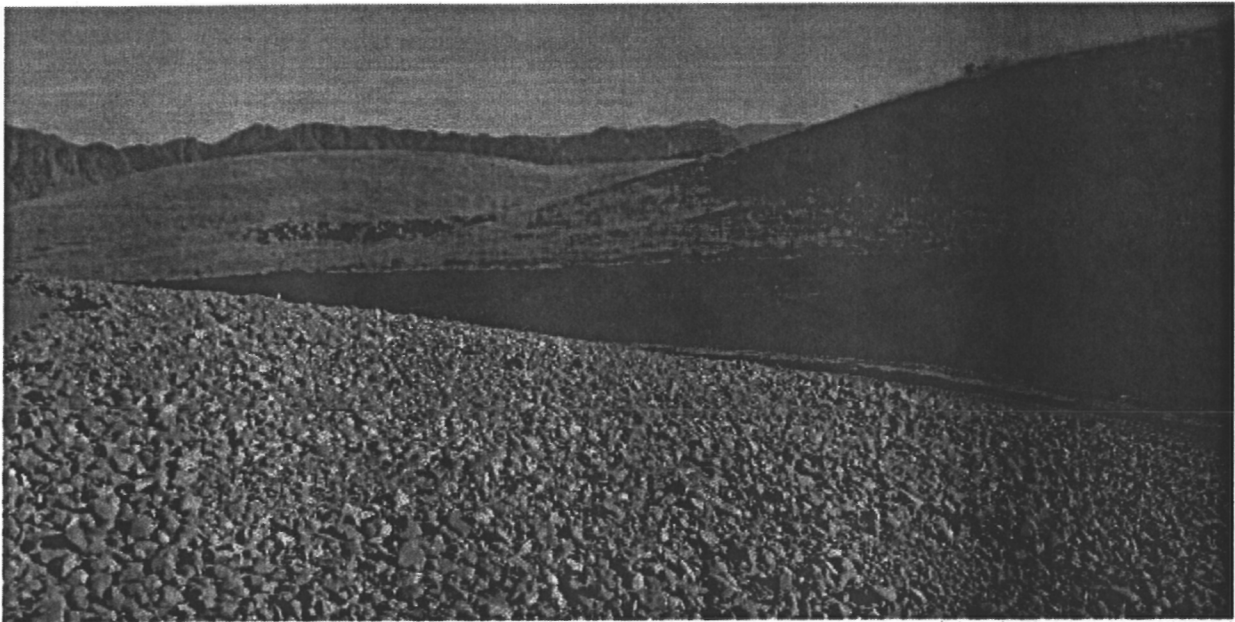
The Final Closure Plan called for a final re-graded impoundment outslope of approximately 3.5:1 (h:v). The Plan also called for the existing embankment / waste materials to be cut back to approximately a 1:1 slope prior to installation of the GCL and rebuilding of the embankment. During initial excavation activities it was determined that the exposed temporary existing embankment and waste materials were much looser and less compact than expected. The Contractor therefore reduced this exterior cut slope to approximately 5:1 to 6:1. An as-built plan view and cross-sections are shown in Appendix J. This slope was much more stable and easier to work on both from the equipment standpoint, and for subsequent GCL installation. IN addition, decreasing the outslope also provided for a more stable long-term configuration for the impoundment.

The following photograph shows a typical (and flatter than 3.5:1) outslope near the southeast side of the impoundment.

Overall this modification to the Closure Plan was an improvement in the long-term stability of the impoundment.

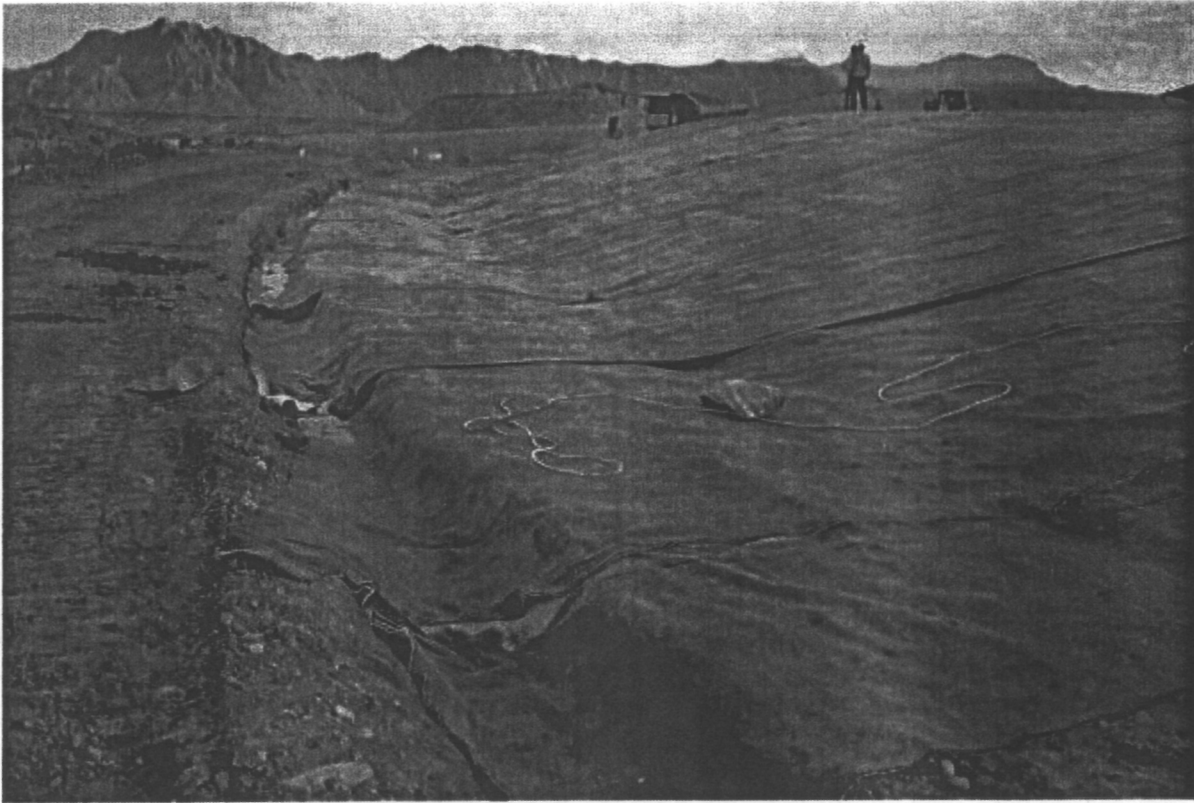
Revisions to the Plan consisted of allowing for a much shorter distance between the existing liner and the 18 inch tie-in trench and in areas where needed allowing for sufficient bentonite to be placed and allow for the GCL extend horizontally across the tie-in location between the two liners. The following photograph shows a typical GCL installation on the northwest side of the impoundment. Appendix B contains a figure showing details concerning this revision (Revised GCL to Existing Liner Tie-In Detail and Recommendations after the Preconstruction Meeting – Apex Site, MEI, August 31, 2005).

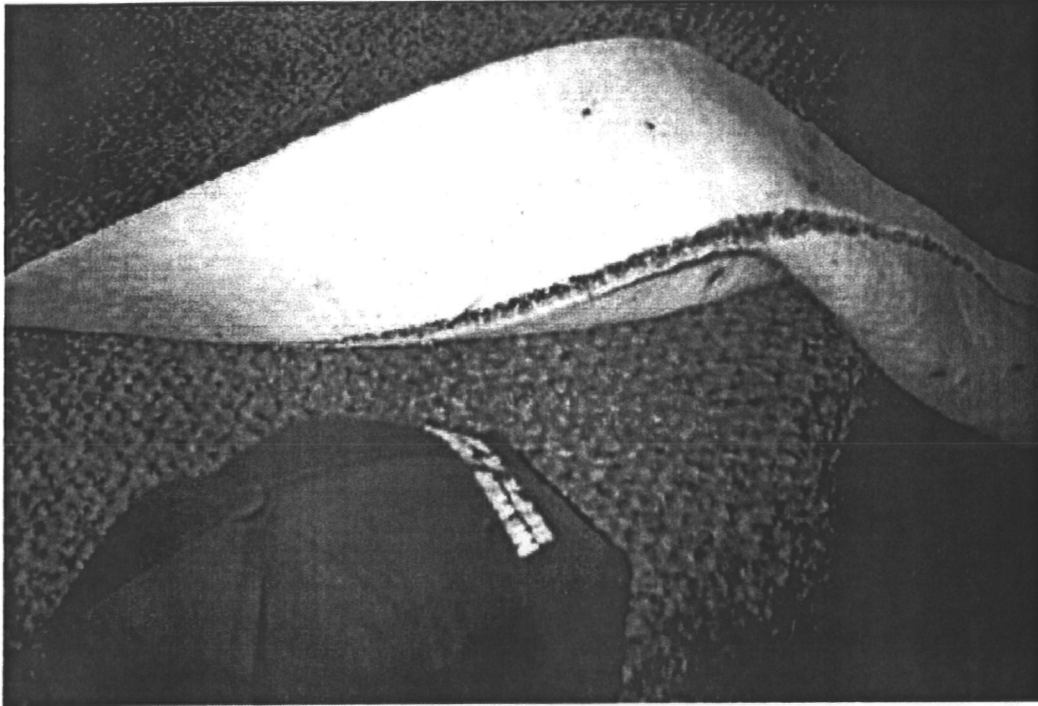
A revision to the GCL to GCL seaming method was approved due to an improvement in CETCO's manufacturing and installation procedures. The Closure Plan had specified that powdered or granular bentonite be hand placed between adjacent and overlapping GCL panels. After the Closure Plan was approved, CETCO developed a "Supergroove" which is now the currently specified method for seams between GCL panels (CETCO 2005). Basically, the Supergroove is not an addition, but a method of pre-cutting the bottom layer of fabric on the GCL. The very small section of fabric is removed to expose the overlying bentonite which exists between the two layers of fabric. This exposed bentonite is then free to form a seal between the upper GCL layer and the lower GCL layer. CETCO has shown that this method produces a seam superior to the older method of hand placing a "bead" of powdered or granular bentonite between adjacent and overlapping GCL panels. The photograph on the following photograph shows the Supergroove. A copy of manufacturer's literature on "Supergroove" is in Appendix C.

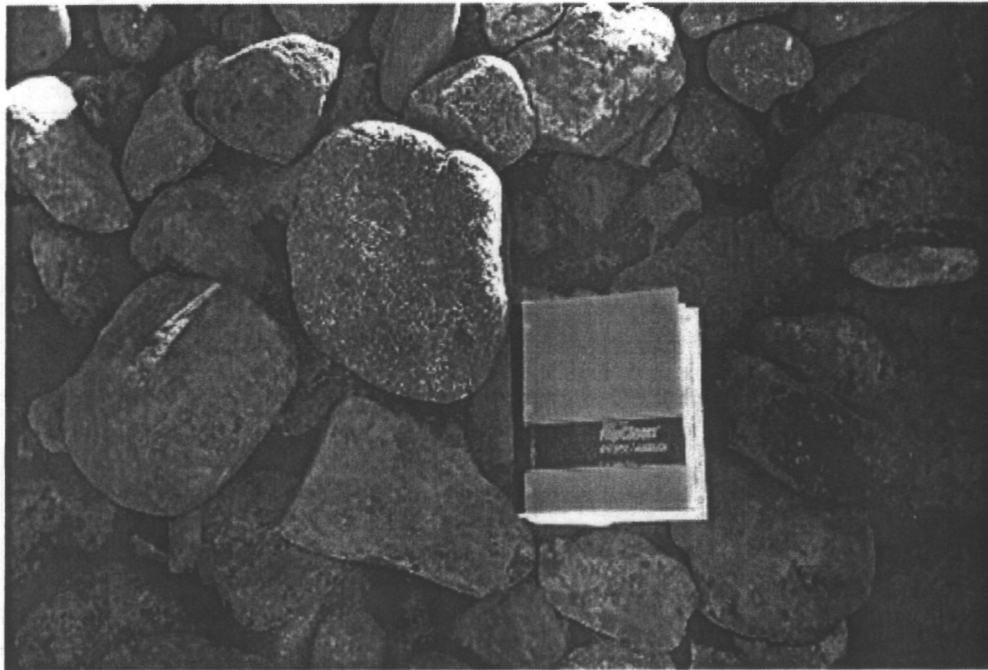
As work progressed in the fall of 2005, the Contractor requested another revision to the specification as they were not able to achieve the gradation specification required in the Closure Plan. The original gradation specification for the $D_{50} = 3$ inch rock is shown in Appendix F as are the results from QA and Contractor provided gradations of materials that were eventually shipped, mixed, and placed on-site. Although the majority of materials originally delivered to the site did not fall exactly within the gradation envelope specified, they were very close. In order to fall within the gradation envelope they required addition of a small quantity of larger (+3 inch and +4 inch materials) and a small quantity of smaller (-1.5 inch materials). The Contractor did have some of these larger and smaller sized materials delivered to the site and

Based on field observations of the final work product (erosion protection materials), and taking into account other revisions to the Closure Plan such as flattening the outslopes from 3.5:1 to approximately 6:1, and increasing the required rock cover thickness from 2 inches to 6 inches, it was determined that the rock materials placed met the intent of the specifications, that is to provide for long-term protection of the outslopes and diversion channel migration. The photograph below shows some of the larger materials delivered prior to mixing.

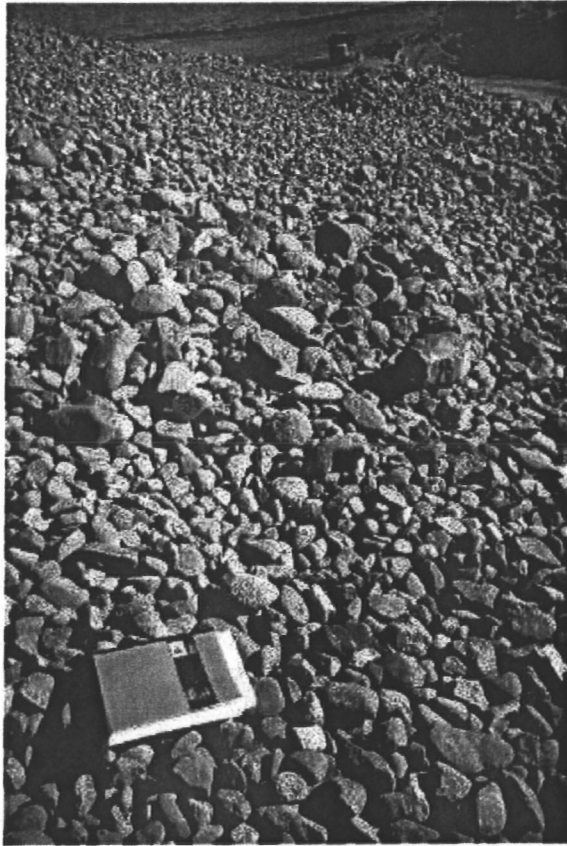
worked at mixing some of them in place with the original materials prior to placement on the outslopes, and mixing some of them after the original materials were placed on the outslopes.

The photograph on the following page shows some of the materials as they were being mixed on the slope.

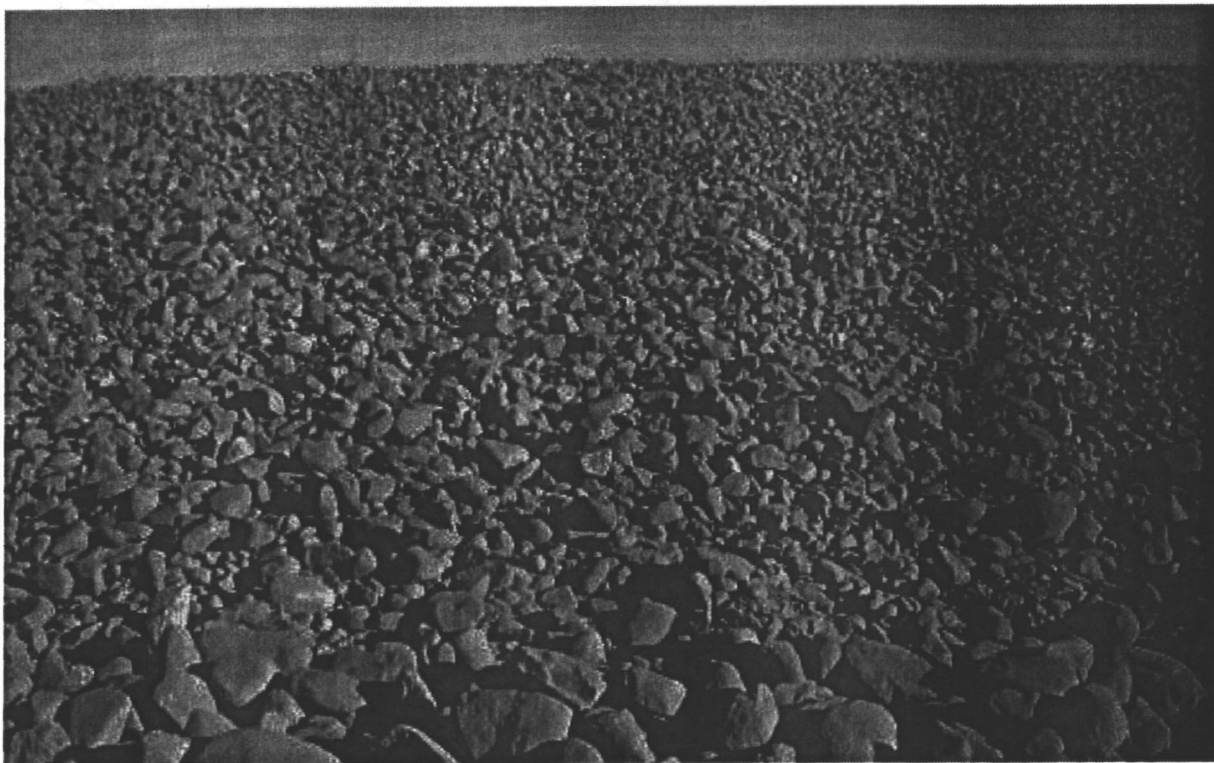
The last photograph shows some of the finished product in-place.

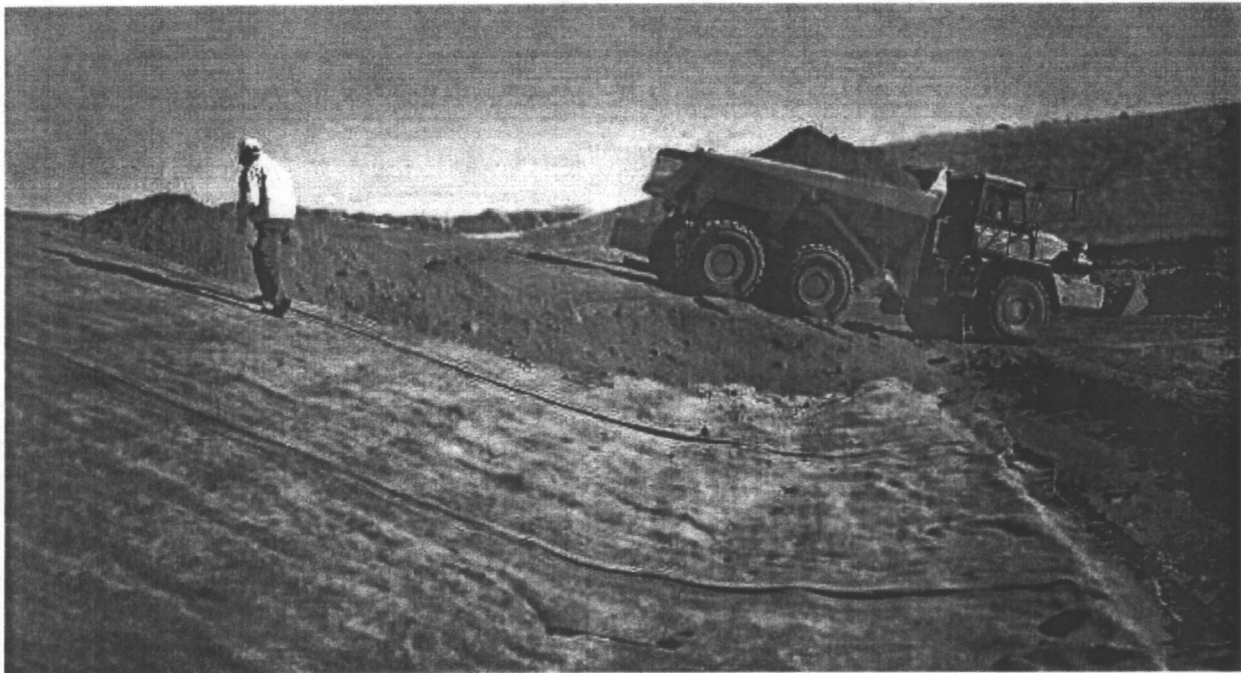
The Closure Plan specified that the 1 foot thick layer of Protection Layer materials (those placed directly on the GCL) were to be taken from the borrow area / Diversion Channel located immediately adjacent to and east of the impoundment. Utilization of borrow from this area would also allow for a wider and more gently sloping diversion channel with a normal flow channel located as far as possible from the impoundment. A wide, nearly flat-bottomed channel would provide for much improved long-term erosion protection. Completion of the Protection Layer work required the excavation of approximately 5 additional feet (vertical) from the borrow area, mainly from the southern end of the channel. Because of this additional excavation the overall final slope of the Diversion Channel decreased from the Closure Plan design by approximately 50 percent. This revision will have the effect of decreasing runoff velocities substantially. Much of this additional borrow material was used near the toe of the impoundment outslope to protect the GCL from vehicle traffic as seen in the photograph below.

The use of this additional material did provide extra protection for the GCL during construction activities, and in addition, created the much flatter than specified 3.5:1 impoundment outslope. However due to the much deeper Diversion Channel configuration, a revision to the final Diversion Channel slopes and routing of surface runoff was implemented in the field. Drawings and details showing the impoundment to Diversion Channel drainage control features are shown in Appendix J (MEI drawings – December 8, 2005).

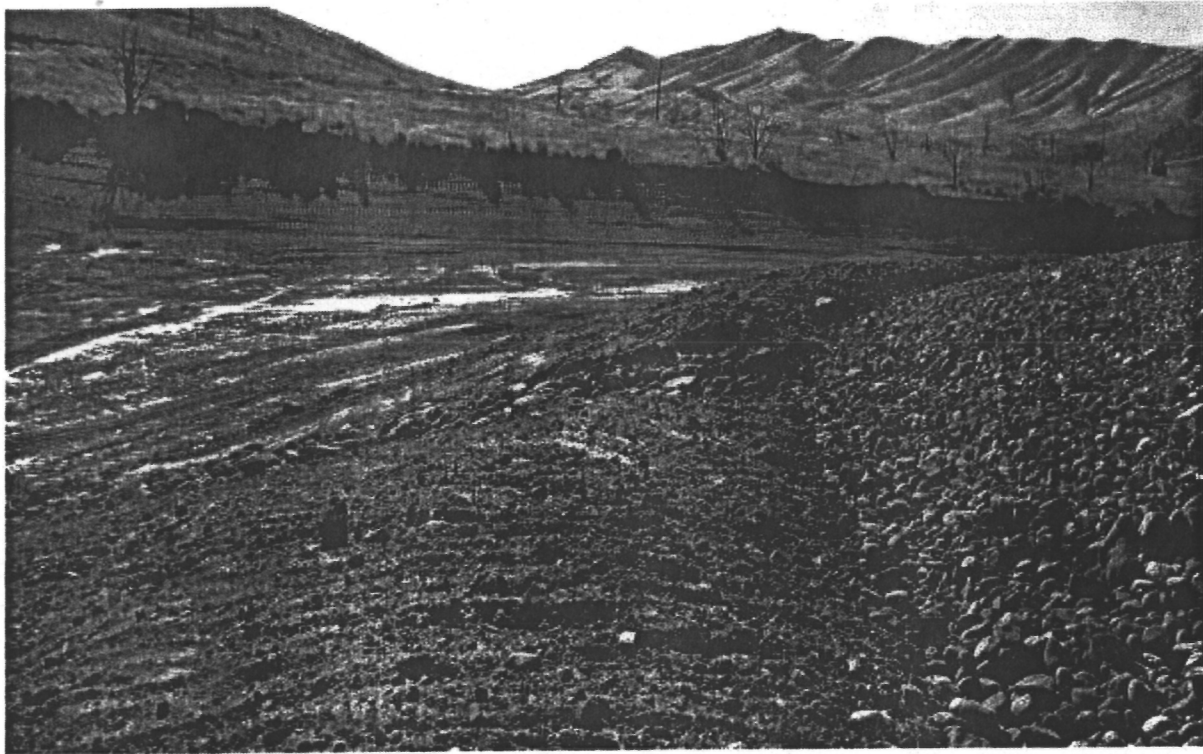
of the completed diversion ditch at the bottom of the impoundment outslope and diversion swales. The first photograph shows the diversion ditch along the impoundment toe.

This revision allowed for surface runoff from the top of the impoundment (and outslopes) to collect at the bottom of the impoundment outslopes and then flow in a controlled manner through smaller diversion ditches and rock lined diversion swales down to the main Diversion Channel floor. The diversion swales will be monitored for future erosion and potential head-cutting back towards the impoundment toe. The following photos show several different views

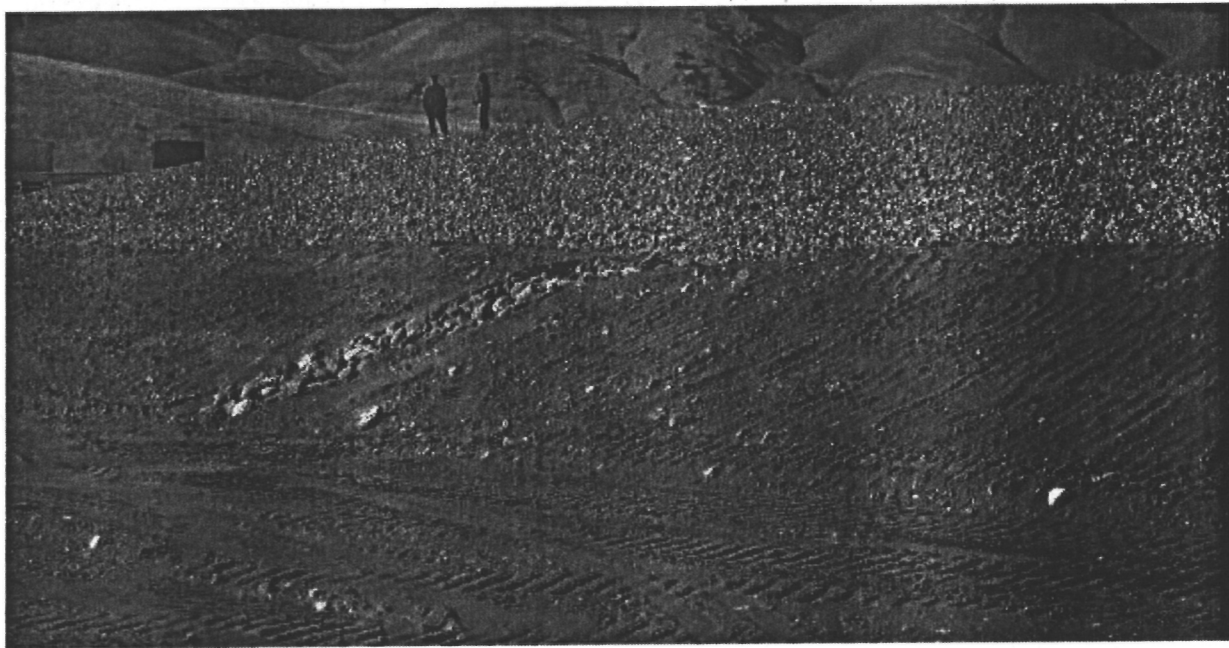
The next photograph shows the completed impoundment outslope and one of the diversion swales that controls runoff from the impoundment toe to the main Diversion Channel floor.

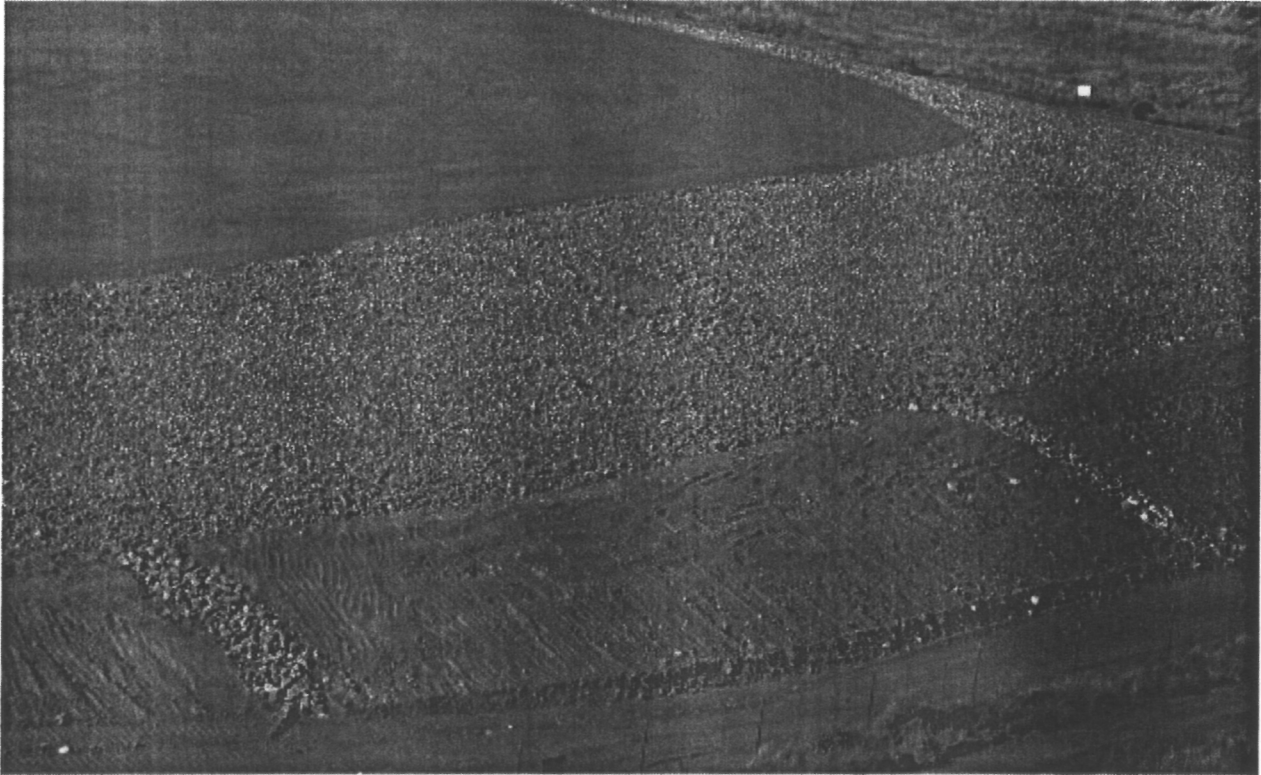
The last photograph shows an overhead view of the completed drainage features on the east side of the impoundment.
